PRE-DEMOLITION BUILDING SURVEY
FOR
ASBESTOS CONTAINING MATERIALS

Property Address:
552 GIFFORD ST.
SYRACUSE, NY

Prepared For:
GREATER SYRACUSE LAND BANK
333 W. WASHINGTON ST.
SYRACUSE, NY

Date: 5/21/2014

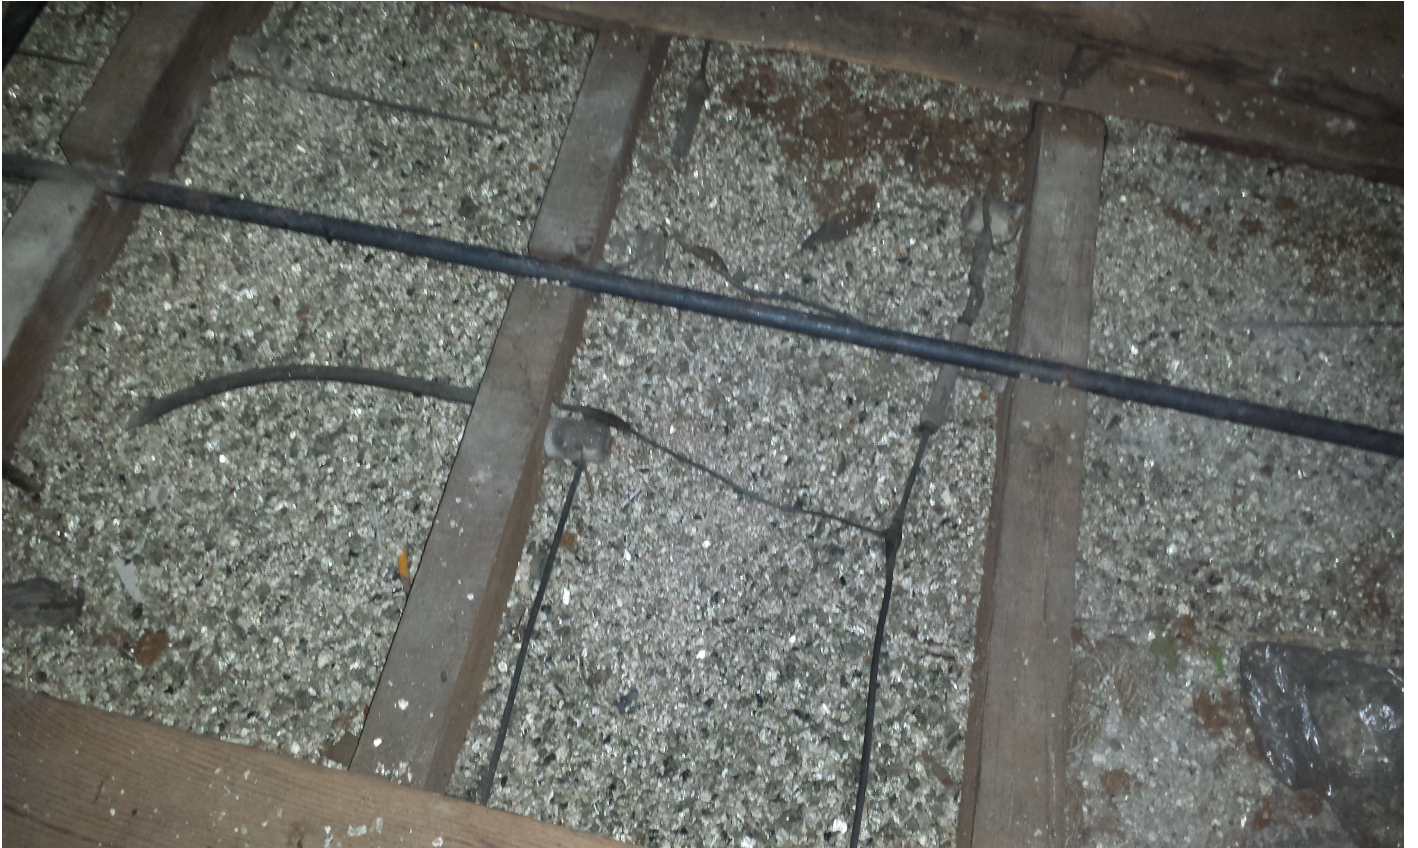
Location	Details of ACM
Attic	Vermiculite – Brown, is located in the Attice on the 2nd Floor just off Bed #2. Approx. 221 sq. ft.
Roof	Flashing – Black is located around 2 Chimneys and also along where each Roof meets the side of the house. Approx. 72 ln. ft.

Vermiculite – Brown

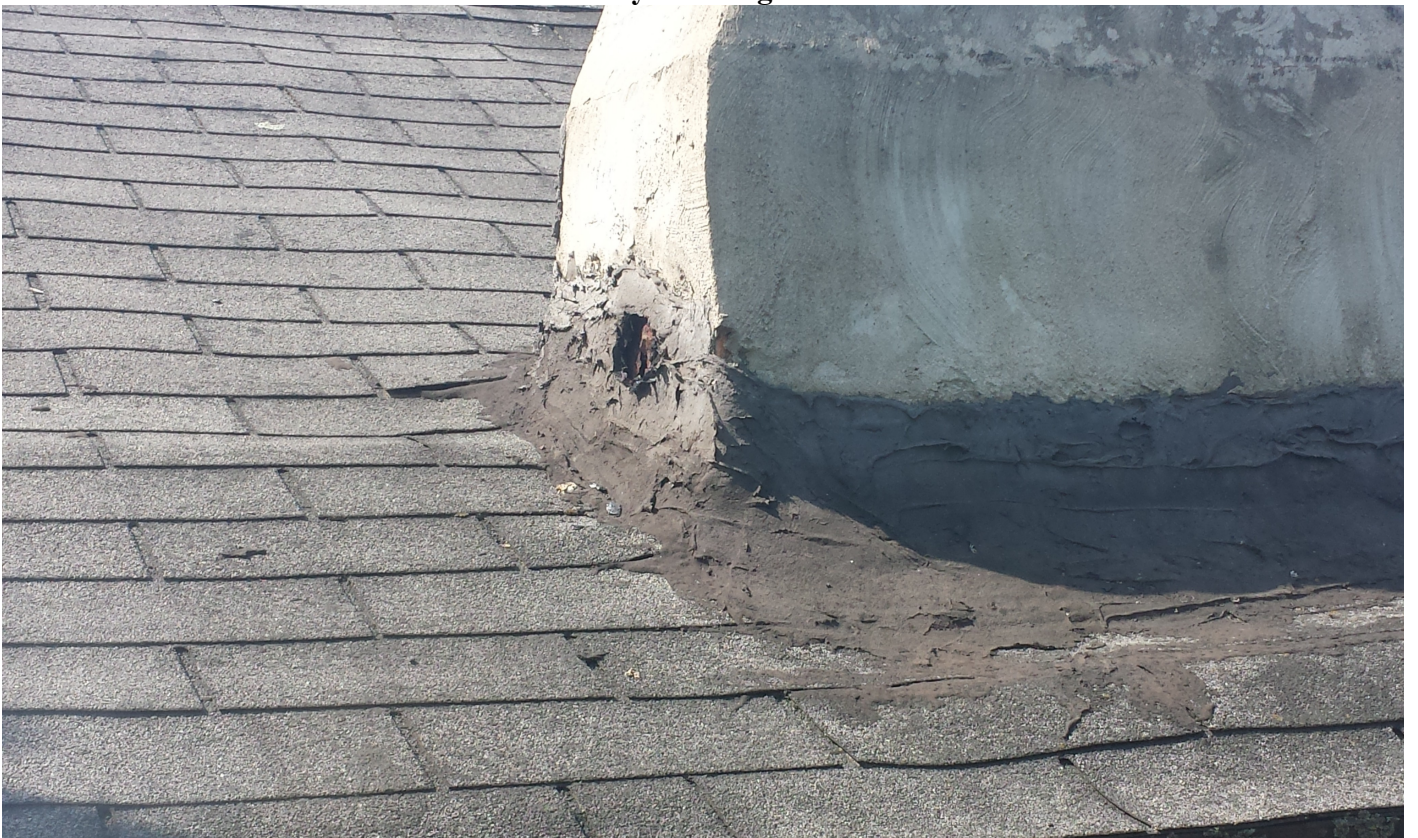
Chimney Flashing – Black

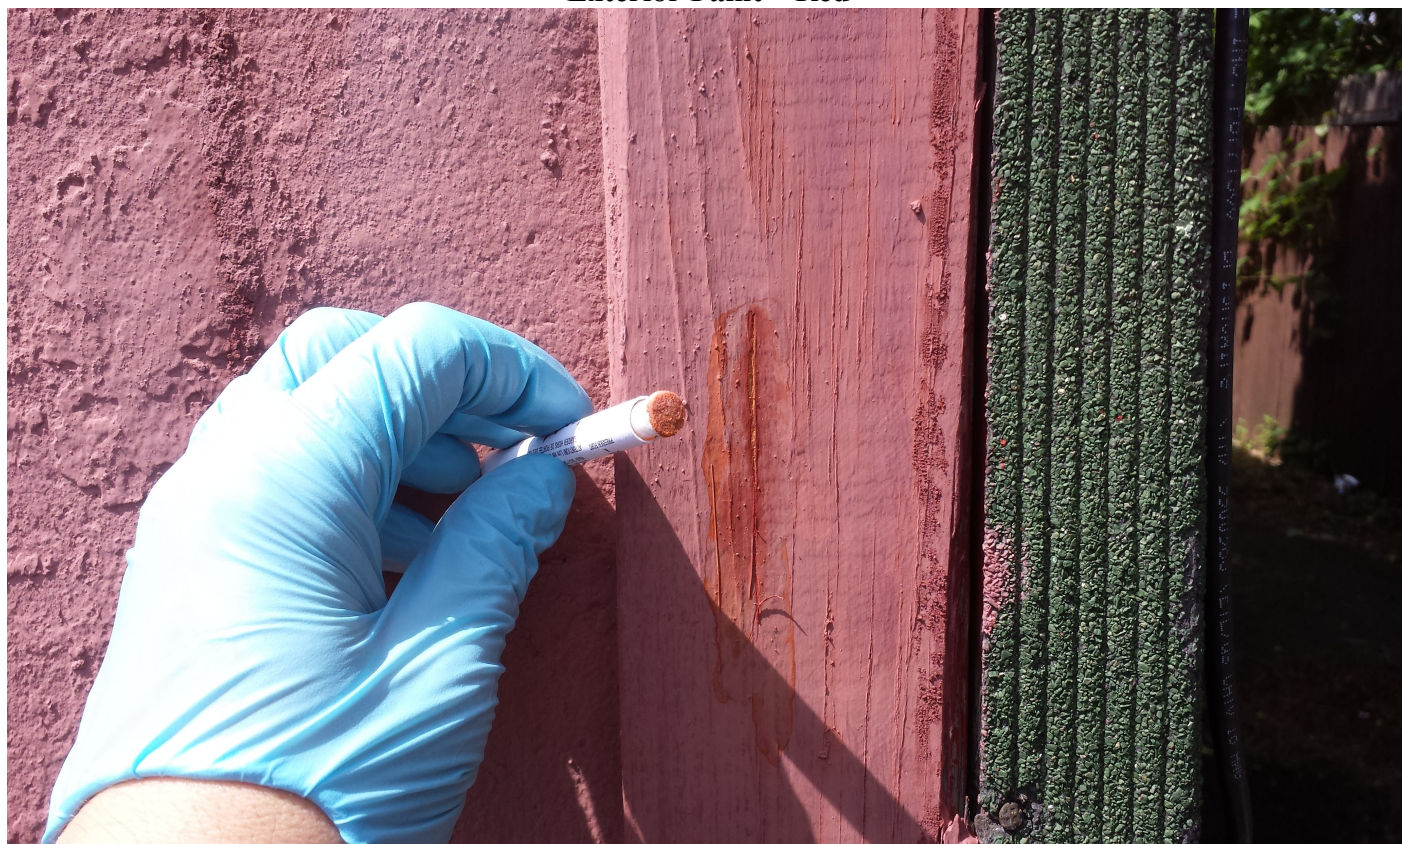
Exterior Paint – Red

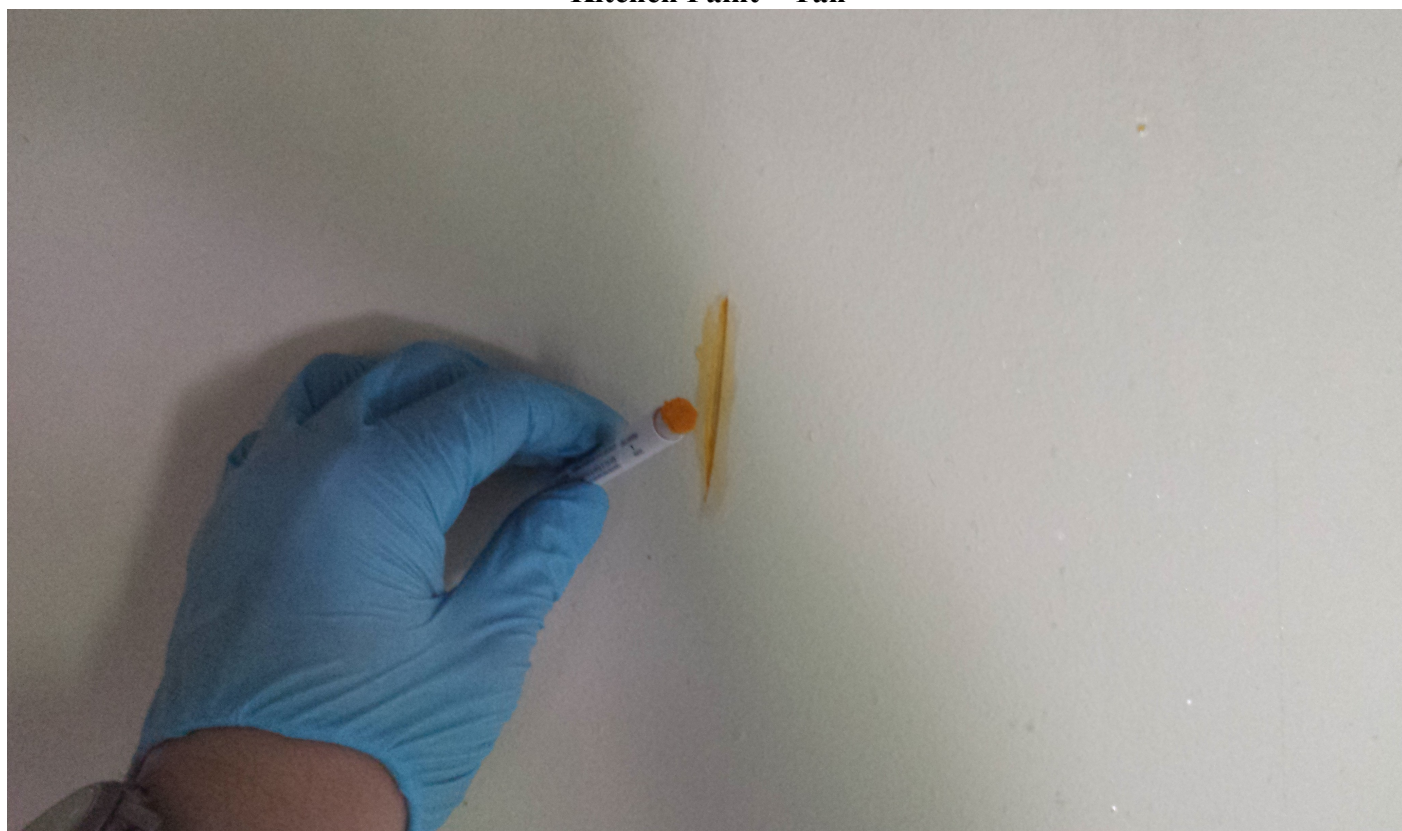
Kitchen Paint – Tan

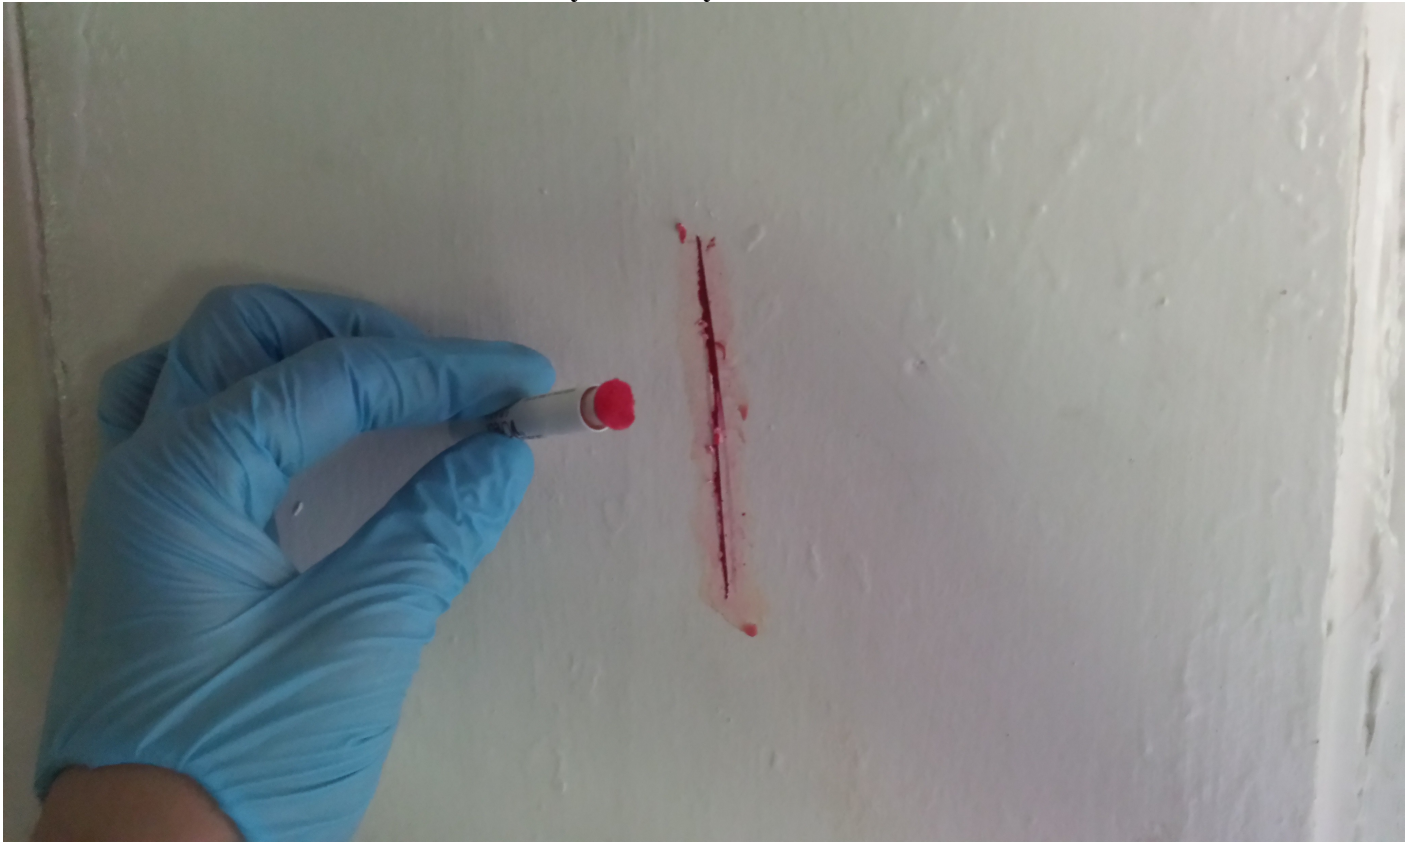
Pantry Doorway Paint – White

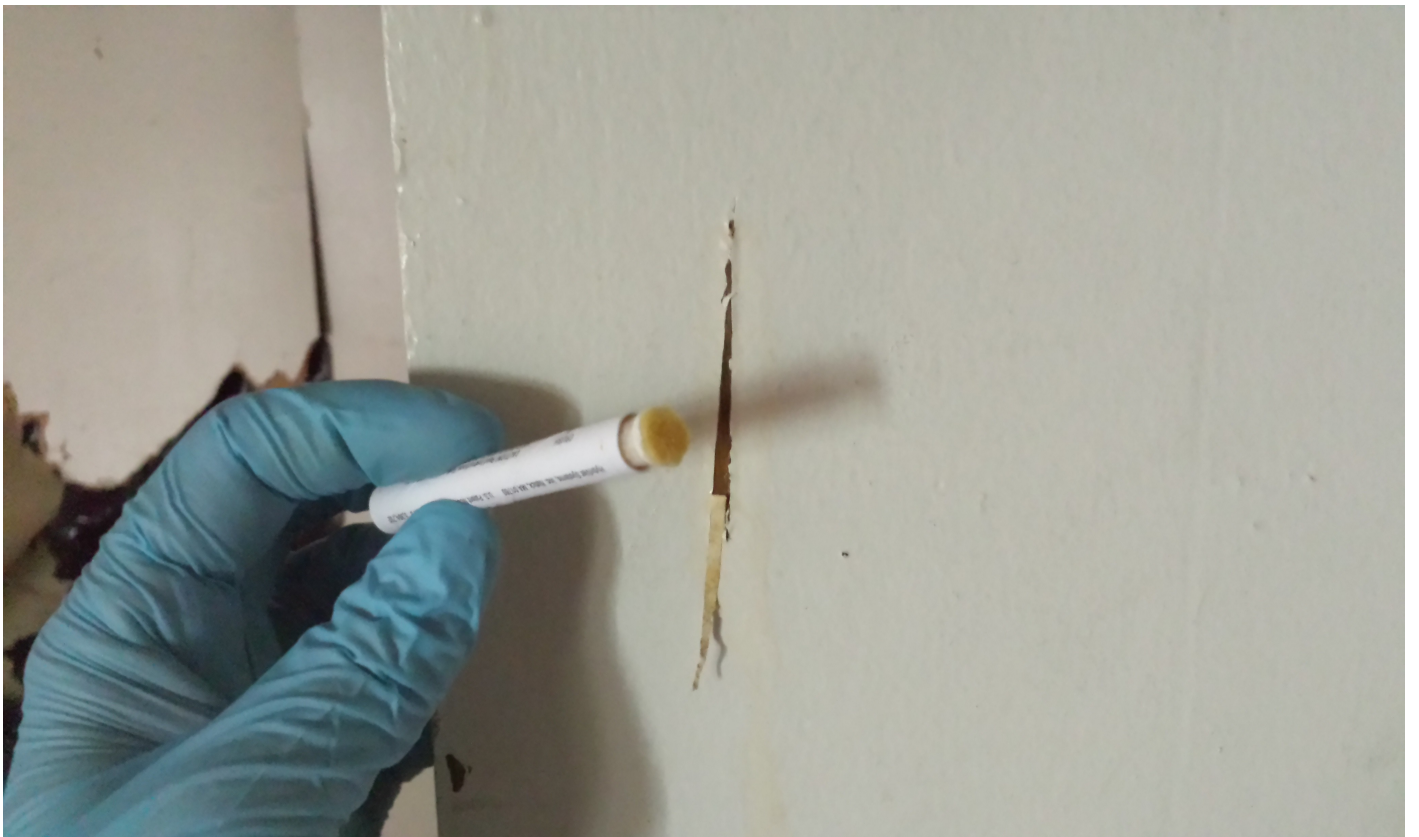
Den Paint – White

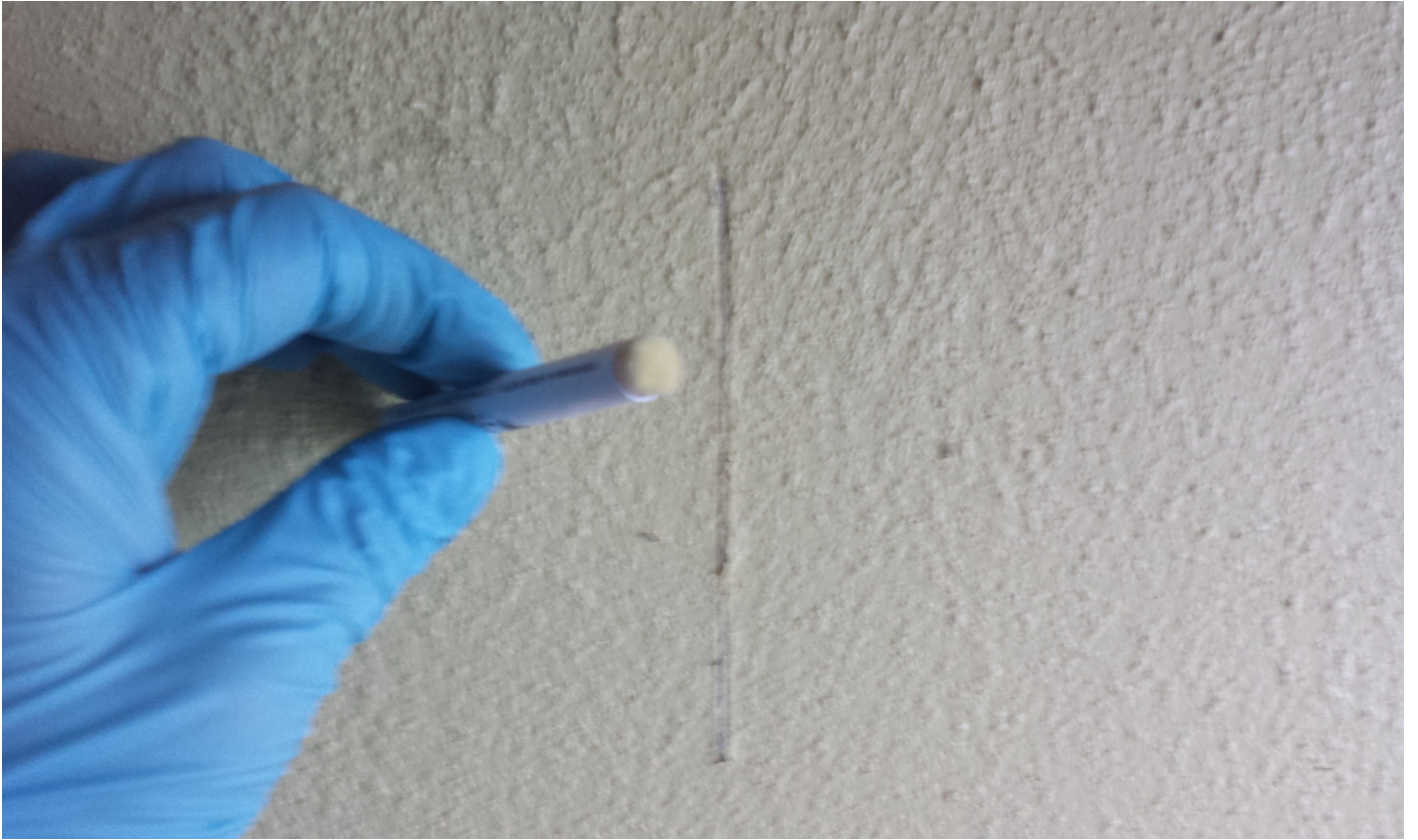
Bathroom Paint – Yellow

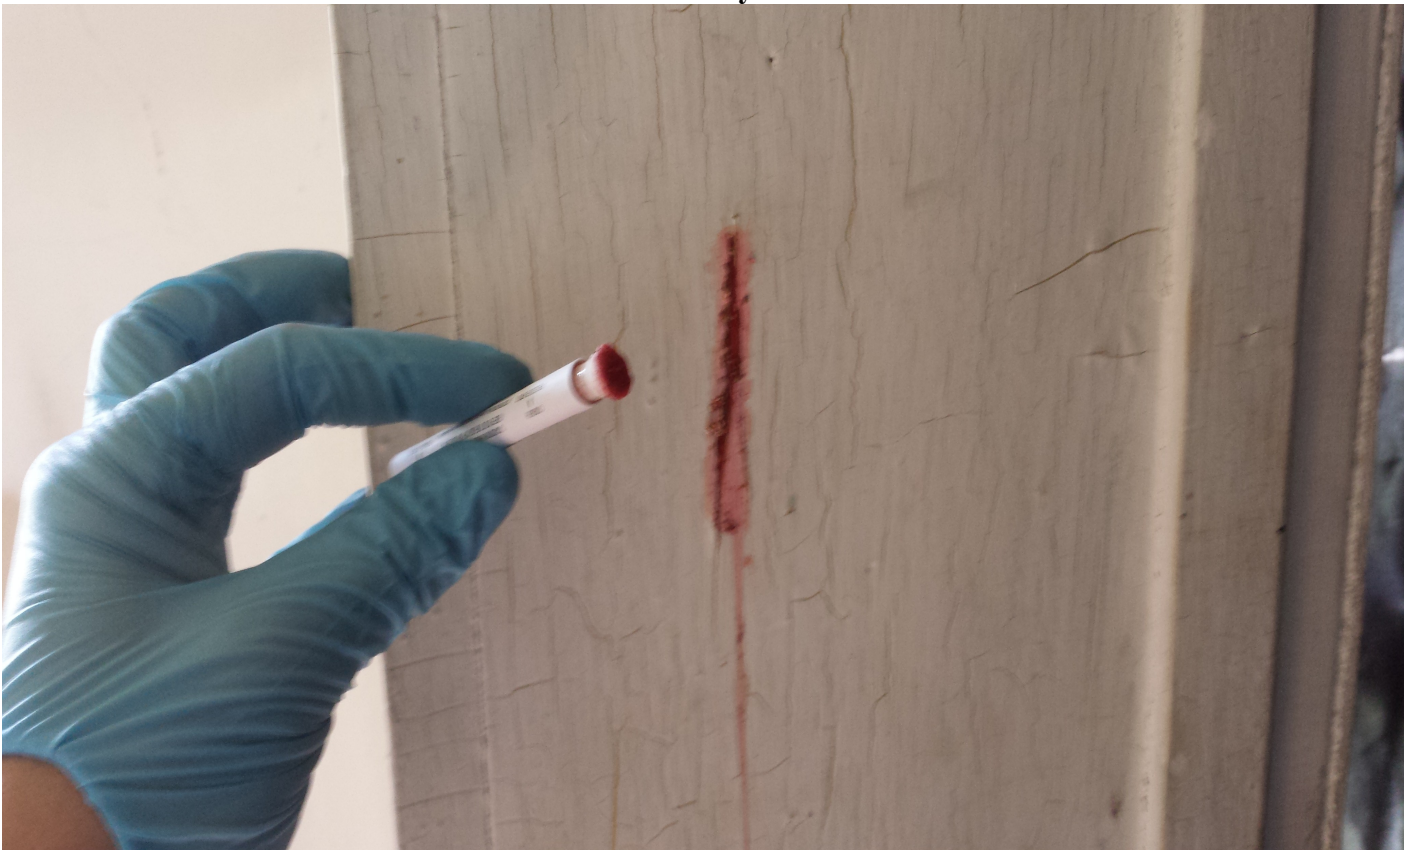
Closet Doorway – White

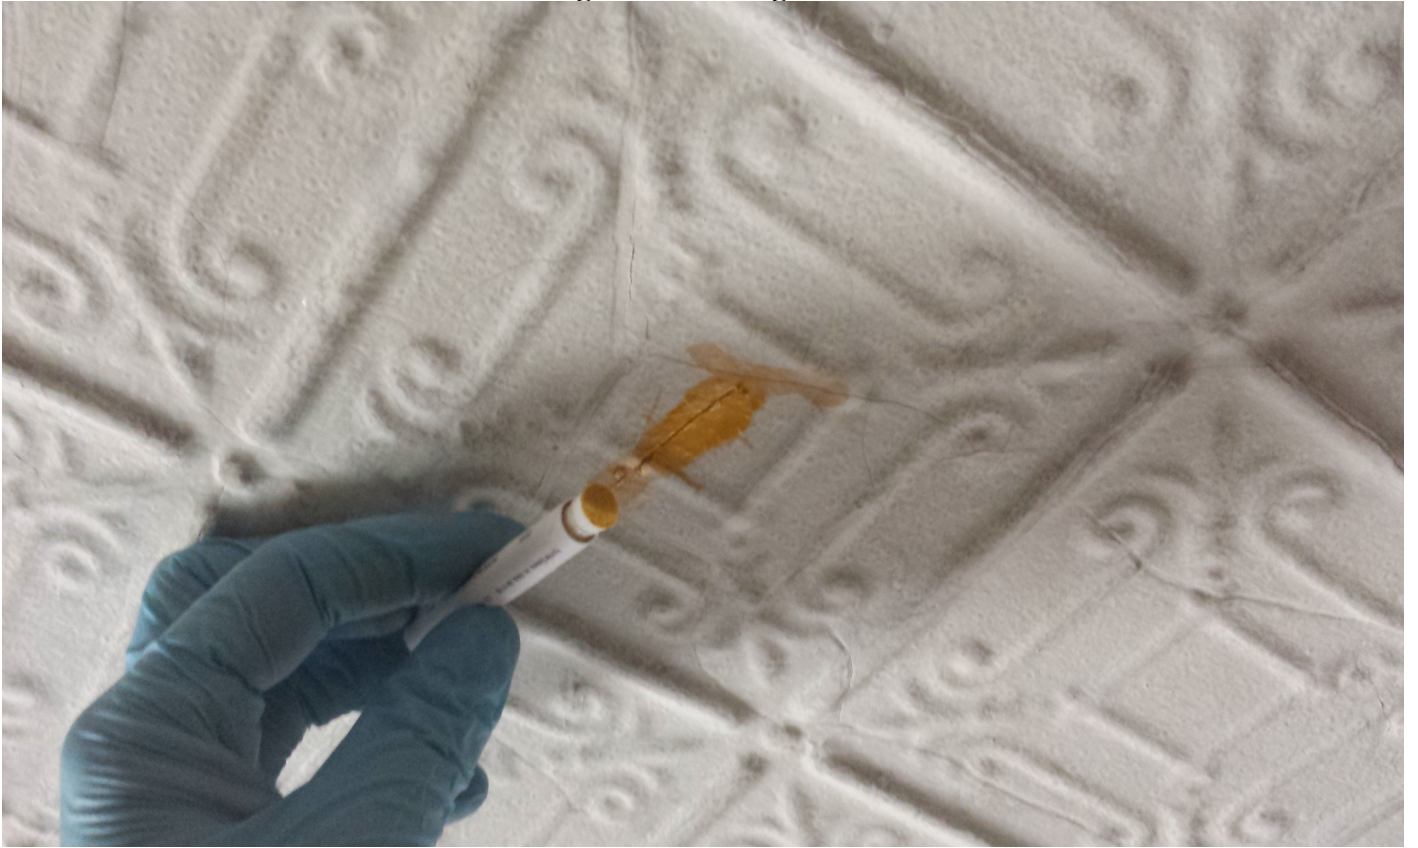
Living Room Ceiling – White

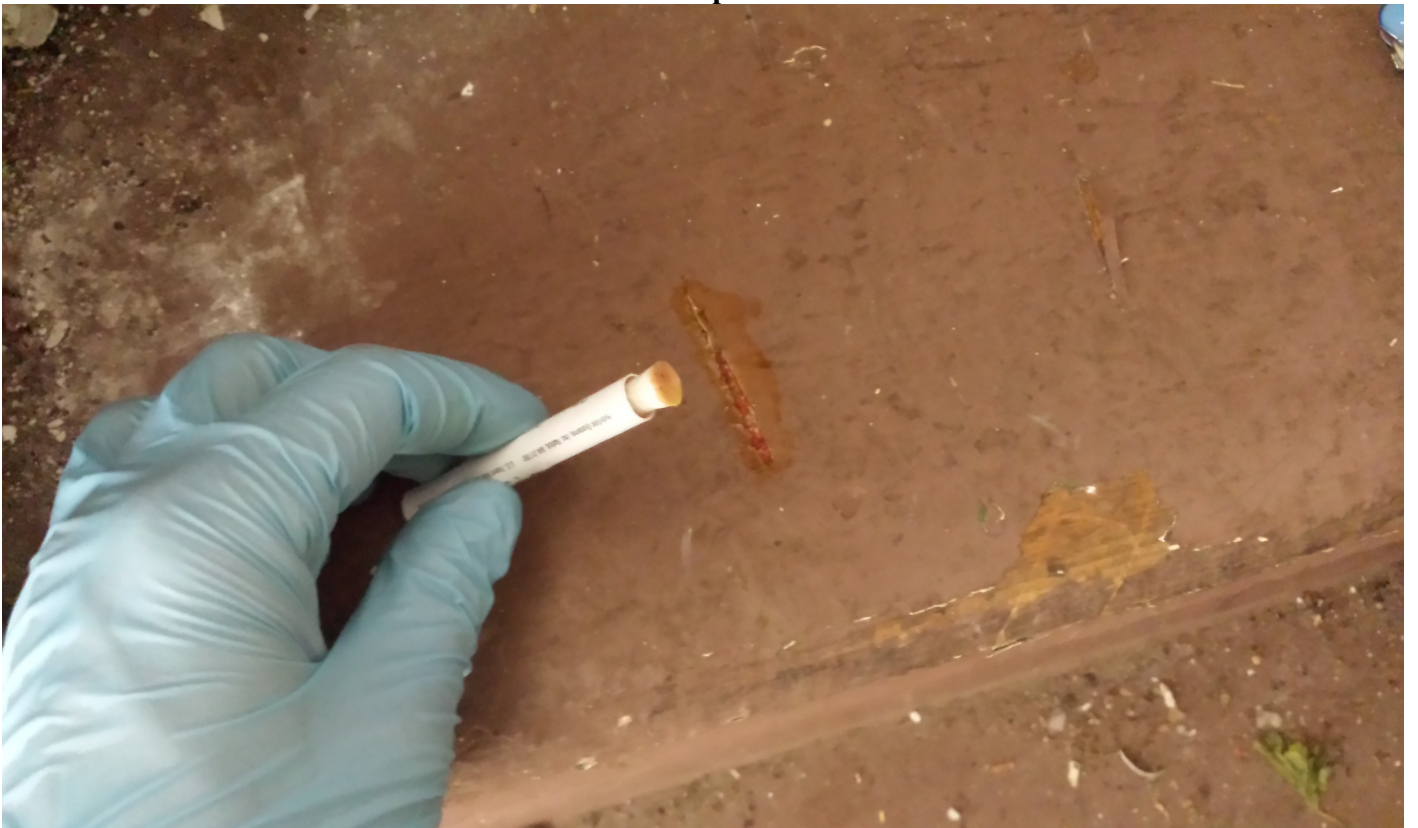
Stairwell Steps – Brown

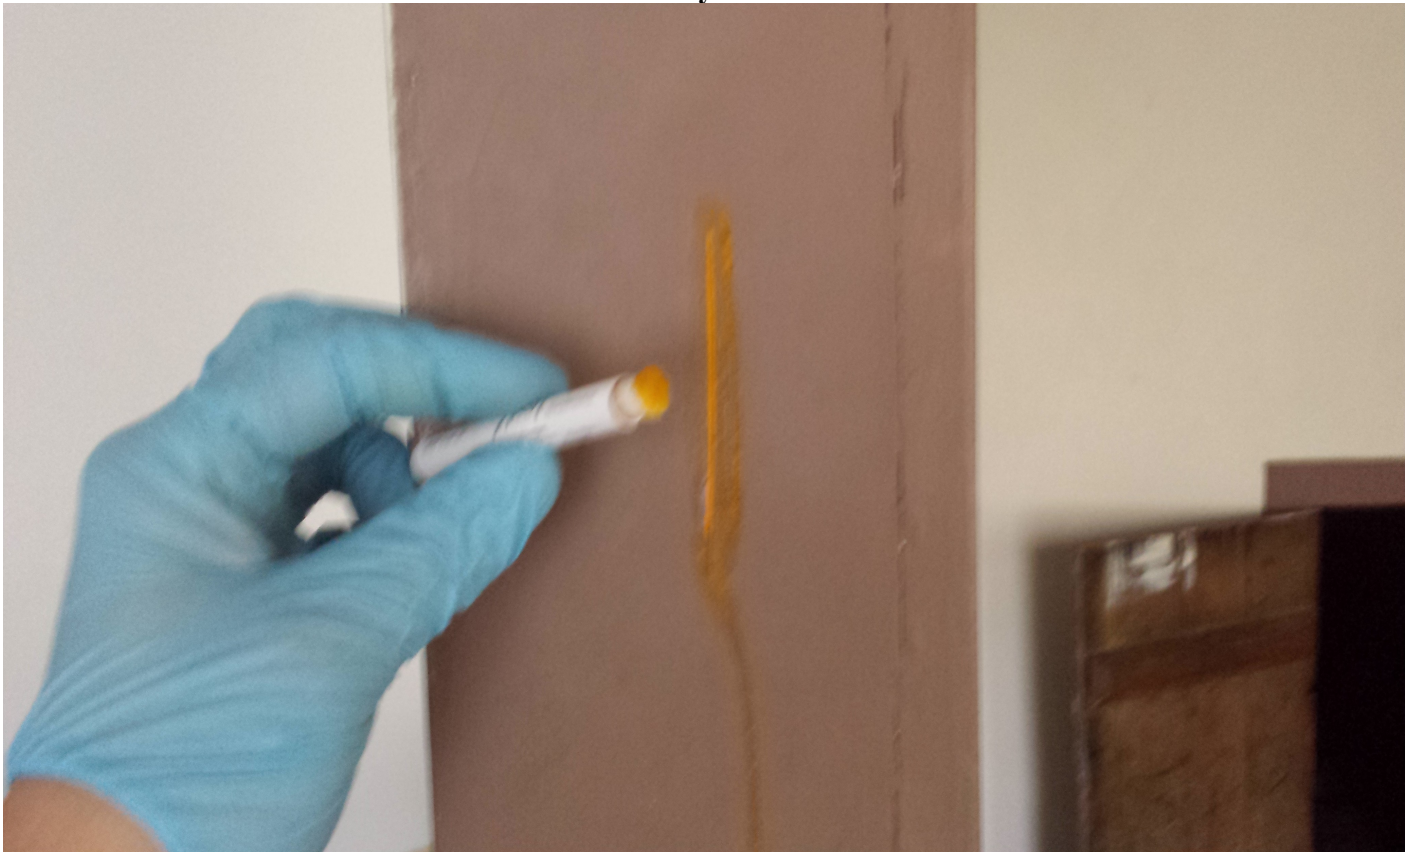
Bed #2 Doorway Paint – Brown
